STATE OF WISCONSIN  
DEPARTMENT OF NATURAL RESOURCES

LAKE SURVEY MAP

MAIDEN LAKE  
OCONTO COUNTY  
SEC. 5-7-8-1B T. 32 N. R. 16 E.W.

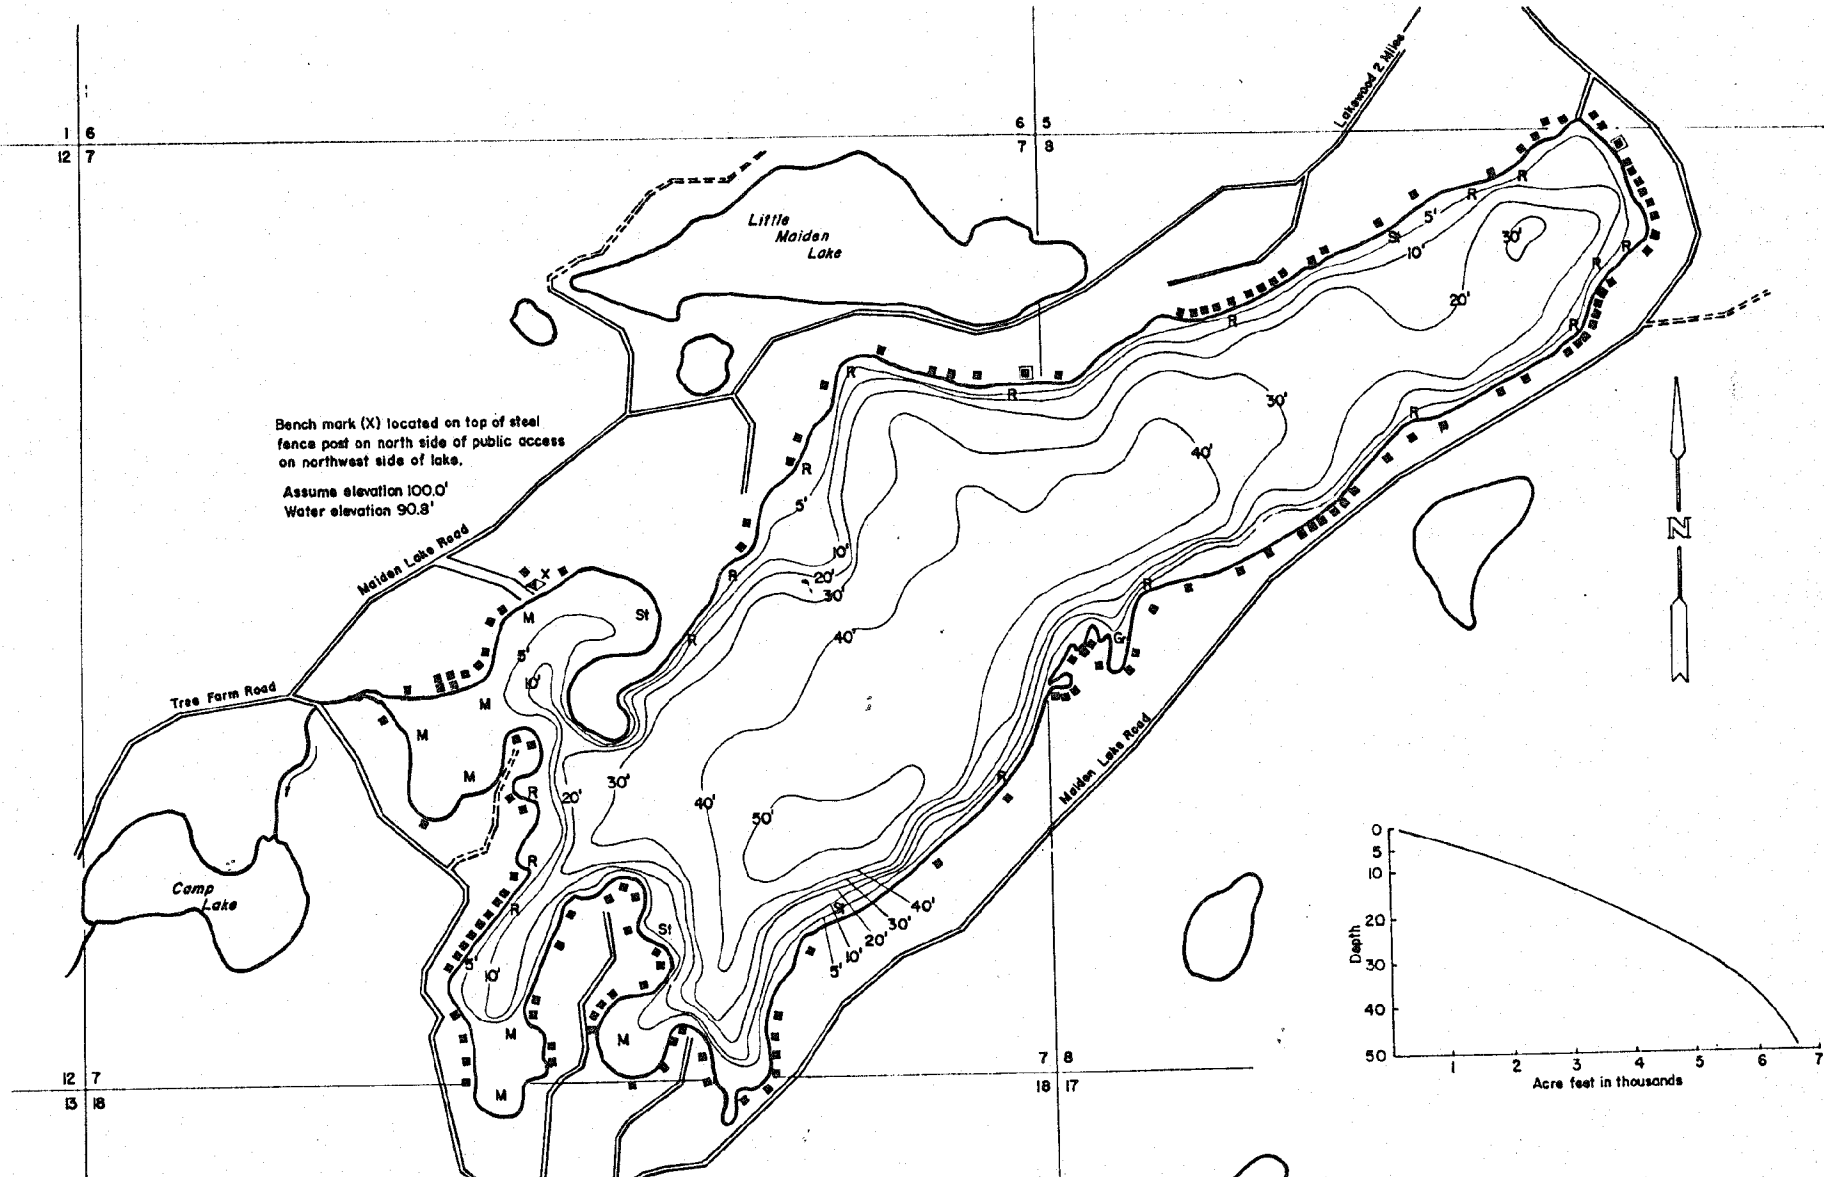
EQUIPMENT	RECORDING SONAR	MAPPED	JUNE MONTH	1978 YEAR
<b>TOPOGRAPHIC SYMBOLS</b>				
(B) Brush	(//) Steep slope	P. Peat	B. Boulders	
(PW) Partially wooded	(~) Indefinite shoreline	Mt. Muck	St. Stumps & Snags	
(W) Wooded	(M) Marsh	C. Clay	⚠ Rock danger to navigation	
(C) Cleared	(S) Spring	M. Marl	T Submergent vegetation	
(P) Pastured	(~) Intermittent stream	Sd. Sand	I Emergent vegetation	
(A) Agricultural	(=) Permanent inlet	St. Sill	F Floating vegetation	
B.M. Bench Mark	(=) Permanent outlet	Gr. Gravel	⚡ Brush shelters	
(D) Dwelling	(D) Dam	R. Rubble		
(R) Resort	(D.N.R.) State owned land	Bc. Bedrock

WATER AREA	269	ACRES
UNDER 5 FT.	19	%
OVER 20 FT.	39	%
MAX. DEPTH	52	FEET.
TOTAL ALK.	90.3	P.P.M.
VOLUME	6545.5	ACRE FT.
MAIN SHORELINE	5.6	MI.
ISLAND SHORELINE		MI.
