STATE OF WISCONSIN
DEPARTMENT OF NATURAL RESOURCES

LAKE SURVEY MAP

NORWEGIAN LAKE WAUSHARA COUNTY
SEC. 5-8 T. 19 N. R. 11 E.W.

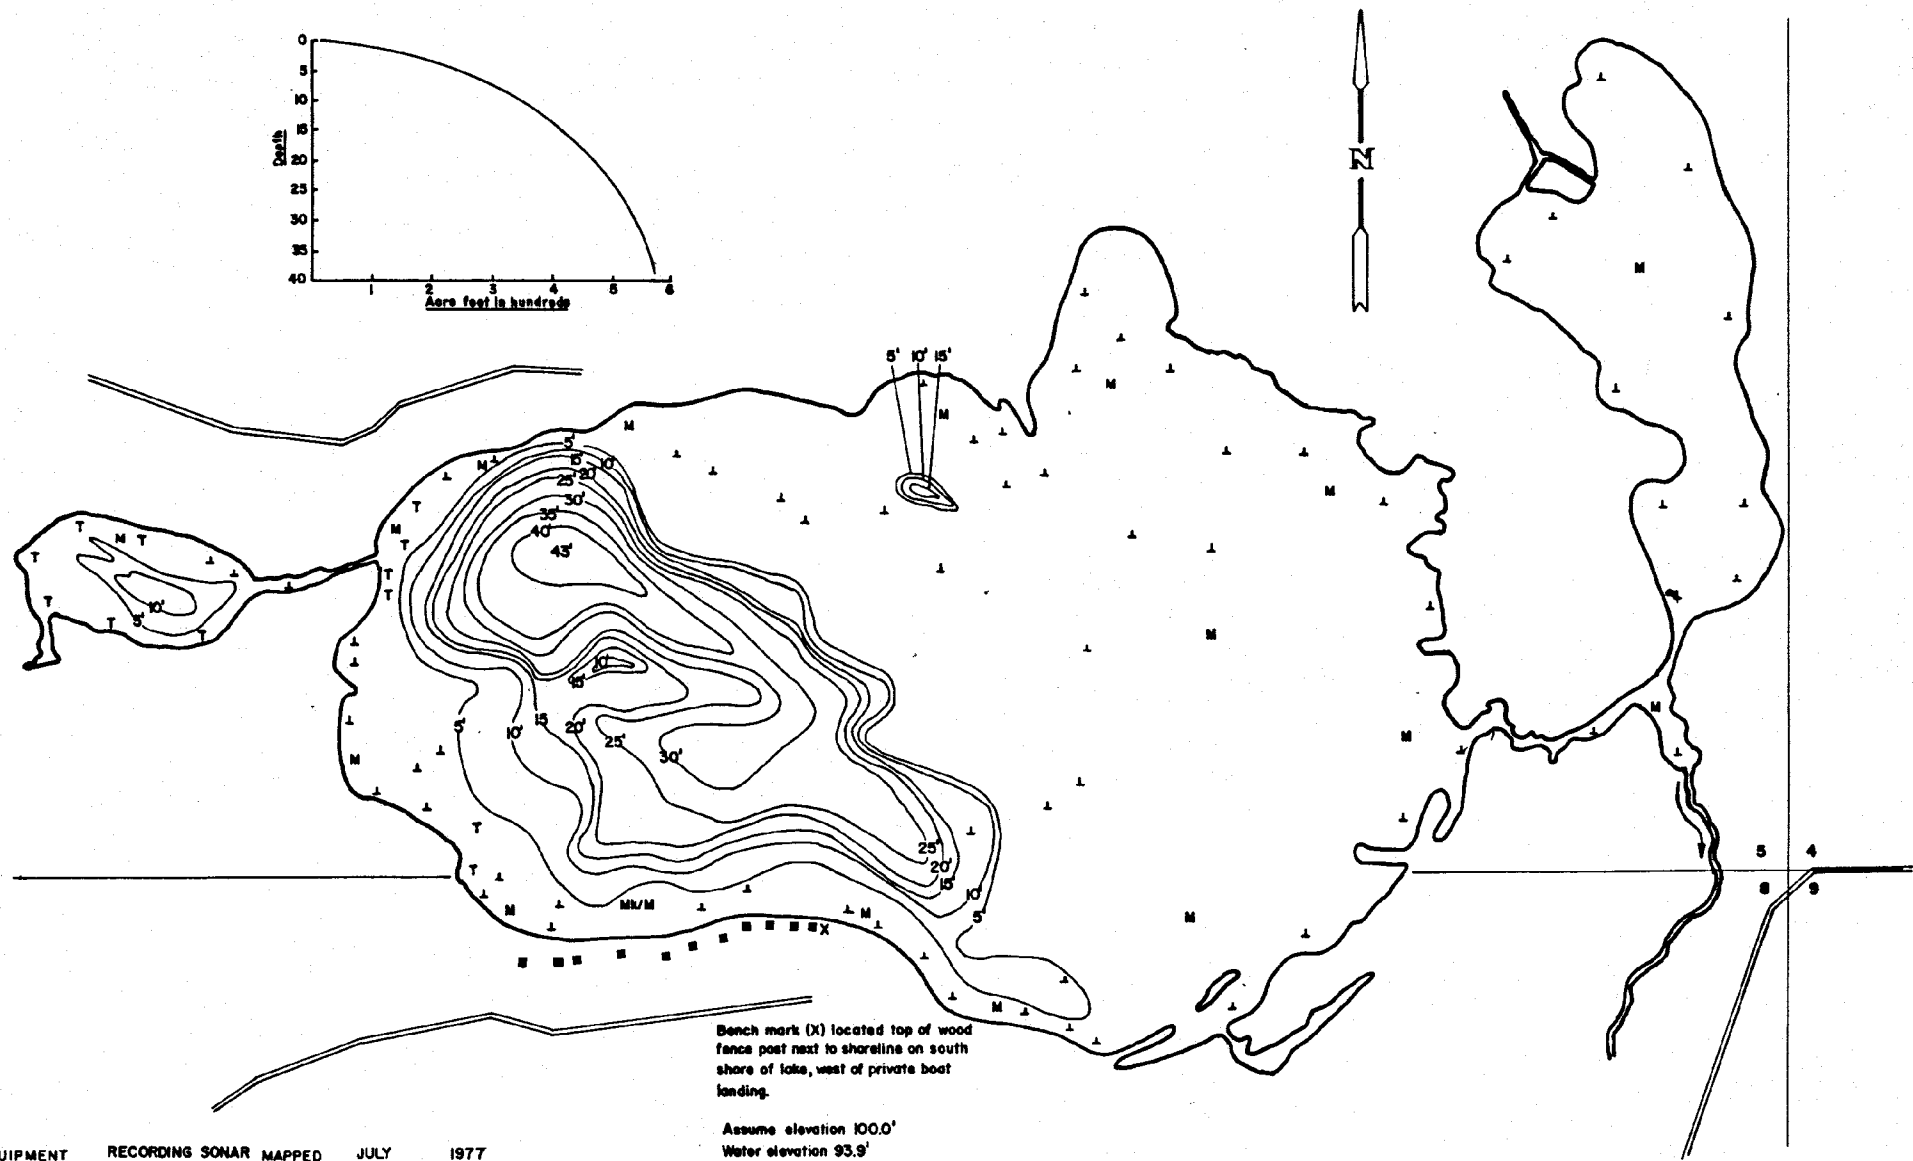
Bench mark (X) located top of wood fence post next to shoreline on south shore of lake, west of private boat landing.

Assume elevation 100.0'
Water elevation 93.9'

WATER AREA	82.13	ACRES
UNDER 5 FT.	66	%
OVER 20 FT.	16	%
MAX. DEPTH	43	FEET.
TOTAL ALK.	120	P.P.M.
VOLUME	570.78	ACRE FT.
MAIN SHORELINE	2.9	MI.
ISLAND SHORELINE		MI.
