STATE OF WISCONSIN
DEPARTMENT OF NATURAL RESOURCES

LAKE SURVEY MAP

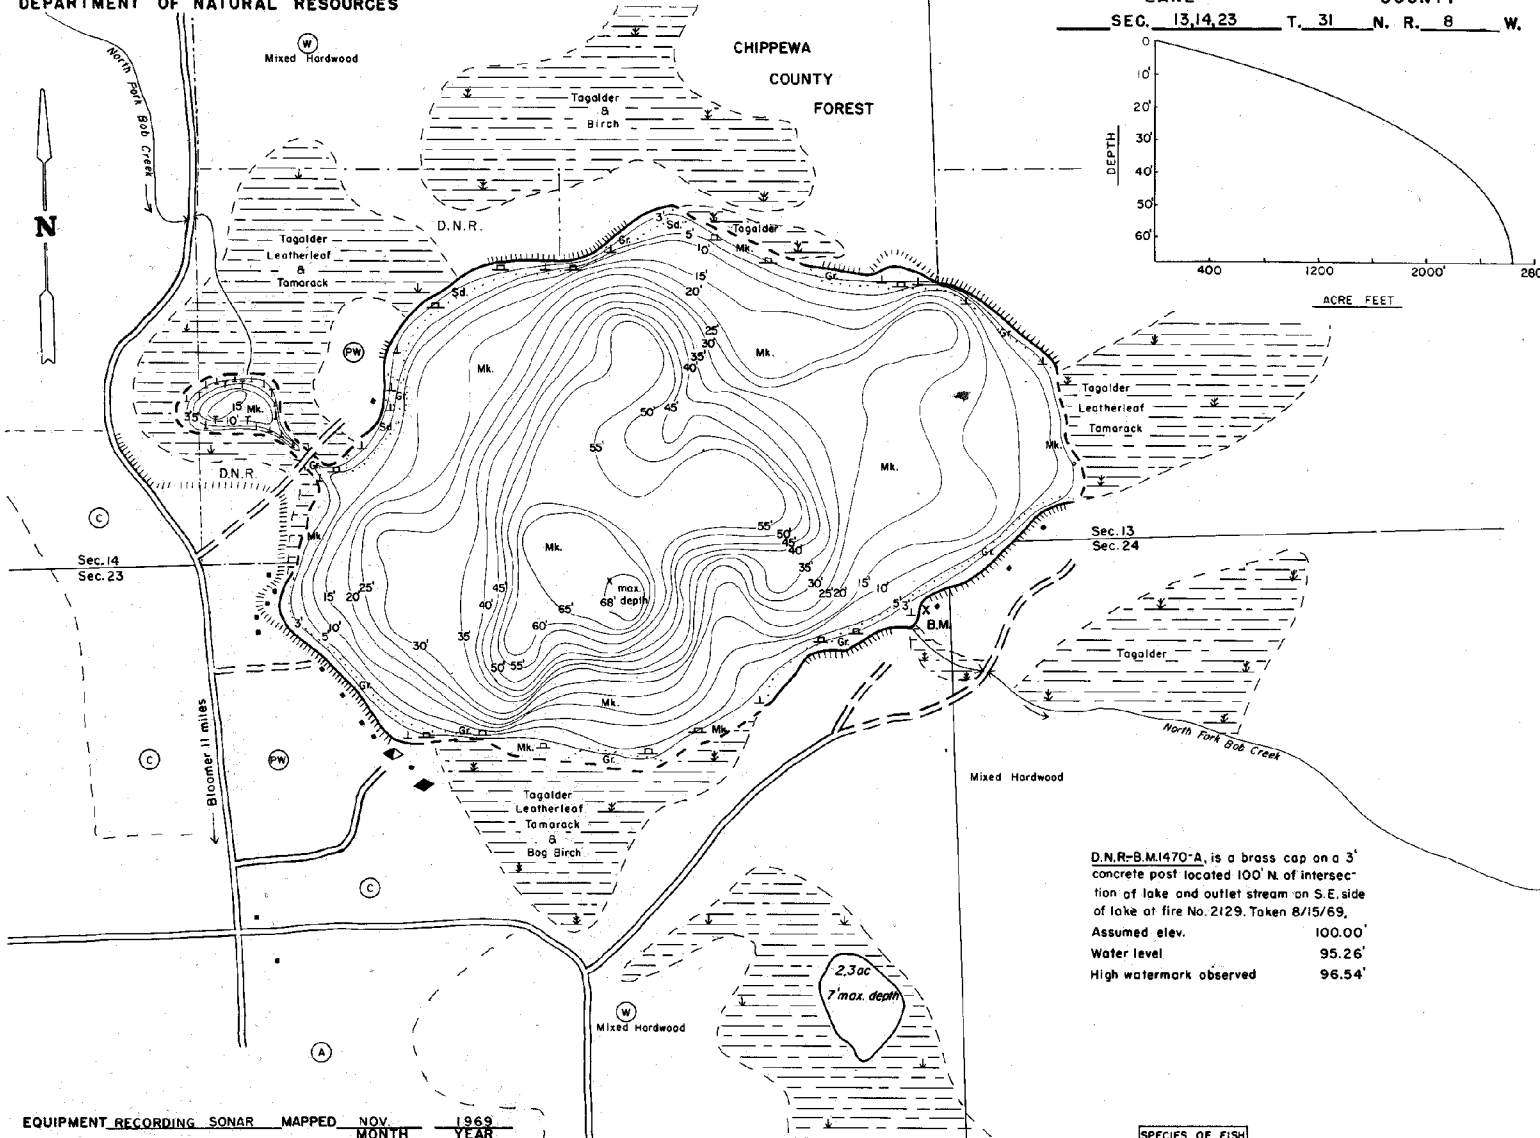
D.N.R.-B.M.1470-A is a brass cap on a 3' concrete post located 100' N. of intersection of lake and outlet stream on S.E. side of lake at fire No. 2129. Taken 8/15/69.
Assumed elev. 100.00'
Water level 95.26'
High watermark observed 96.54'

EQUIPMENT RECORDING SONAR MAPPED NOV 1969

WATER AREA 96.60 ACRES
UNDER 3 FT. 6 %
OVER 20 FT. 55 %
MAX. DEPTH 68 FEET.
TOTAL ALK. 20 P.P.M.
VOLUME 2624.05 ACRE FT.
SHORELINE 1.76 MILES
